## Contrasting Restoration Histories of the Williamson and Wood River Fluviodeltaic Systems, Upper Klamath Lake

Michael L. Hughes<sup>1</sup>  
David Thaumert<sup>2</sup>  
Daniel King<sup>1</sup>

Oregon Institute of Technology  
Klamath Falls, OR

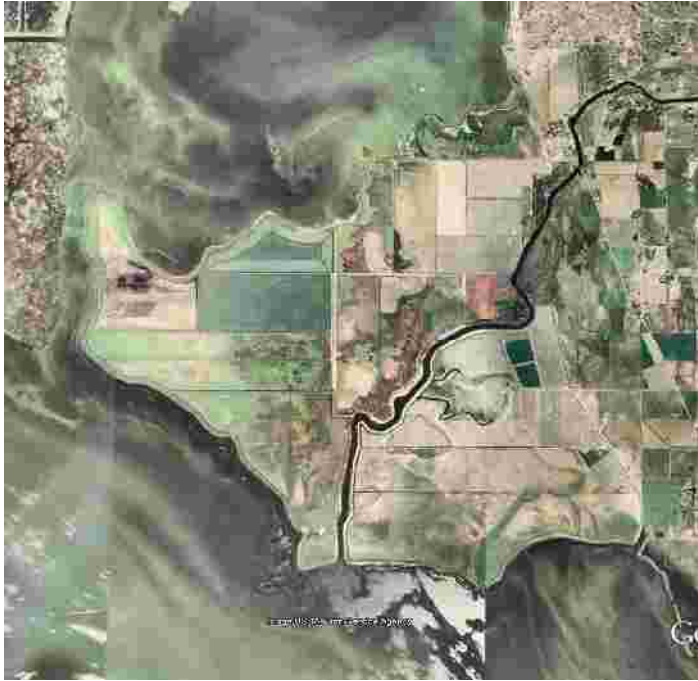
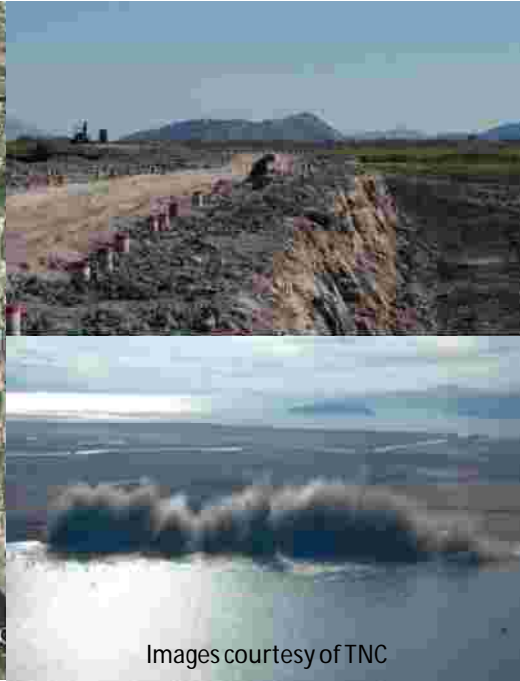
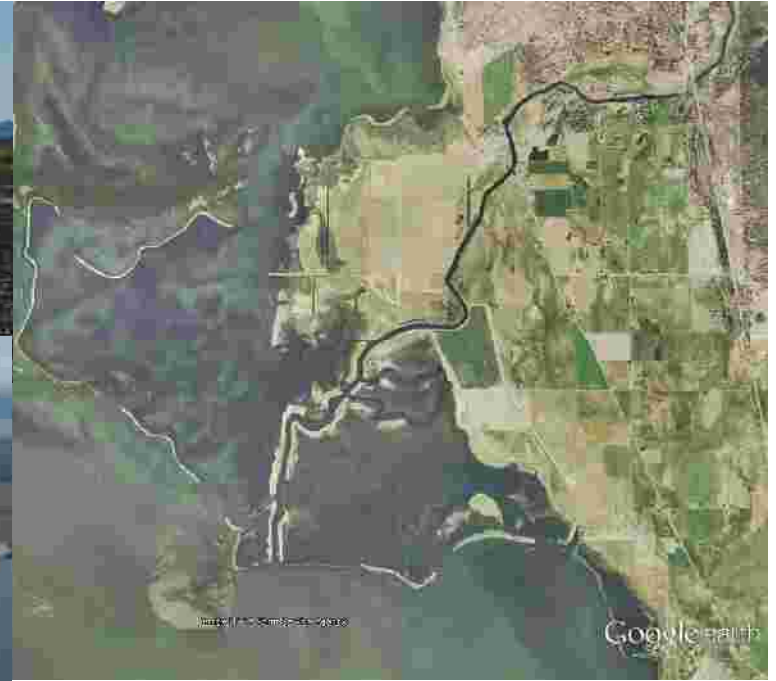
Williamson River Delta Restoration, 2006-2008

6-16-2006

8-1-2011

Excavation and levee blasting

Excavation: ~1.7 million cubic yards, ~\$7 million

Levee breaching resulted in restoration of a variety of vegetative communities and open water habitats

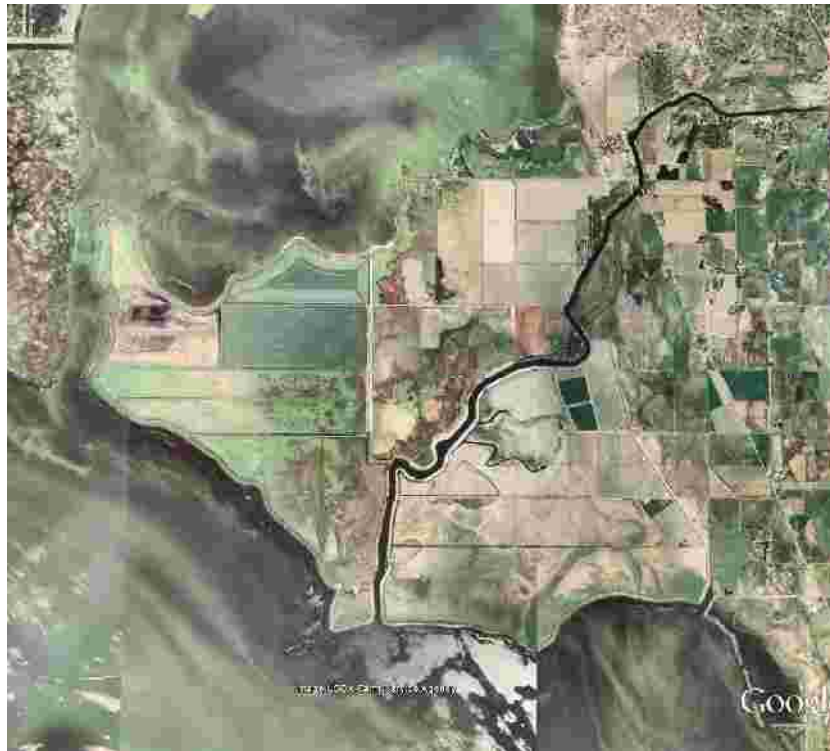
Emergent communities especially important to native sucker that spawn in Williamson-Sprague Rivers

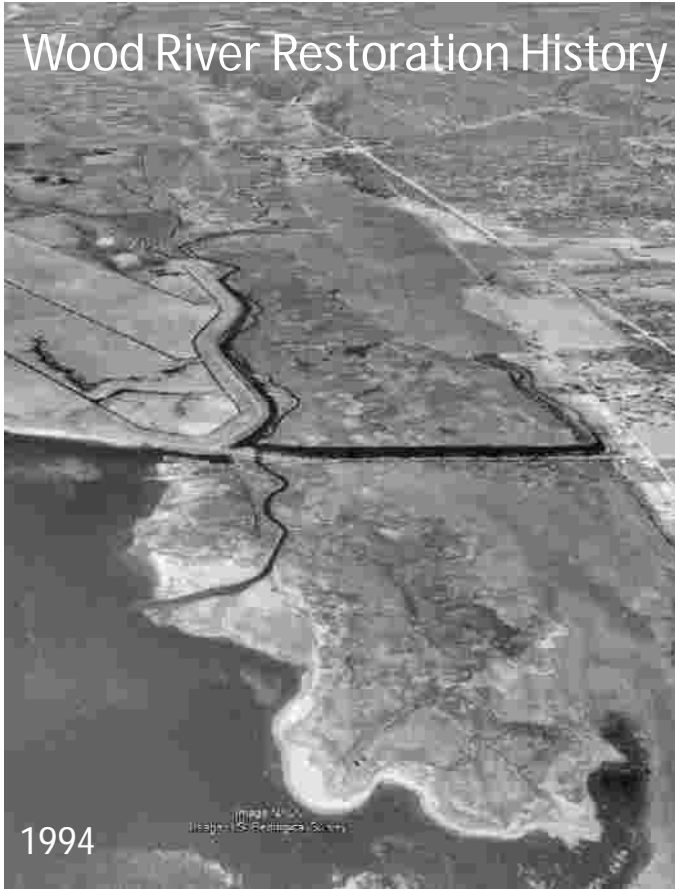
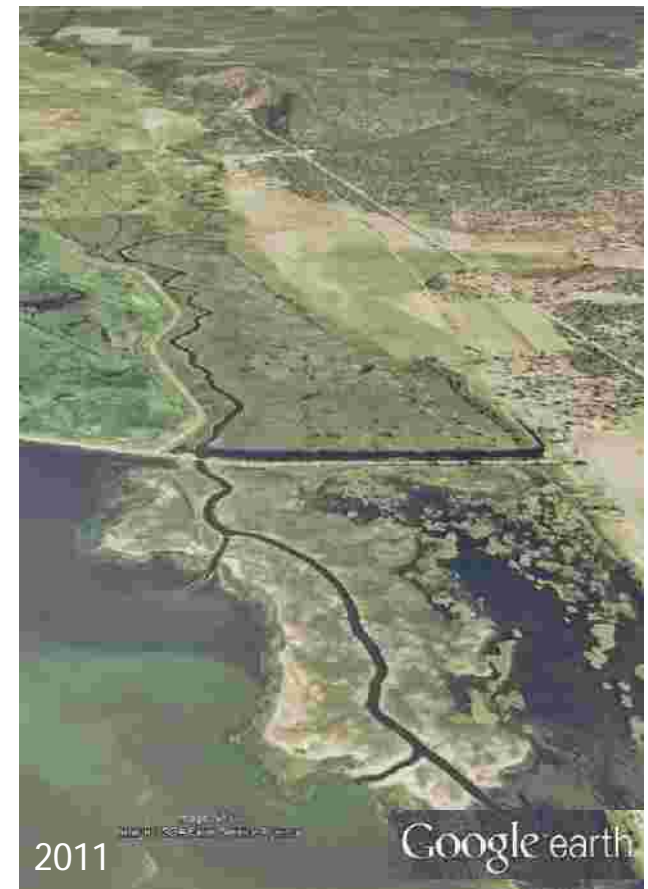
# Wood River Restoration History

Channelization  
Wetlands Drained

1998-2000

Re-sectioning  
Re-meandering  
Floodplain reconstruction  
Delta extension

2009-2010

Birdfoot excavation  
Floodplain supplemented

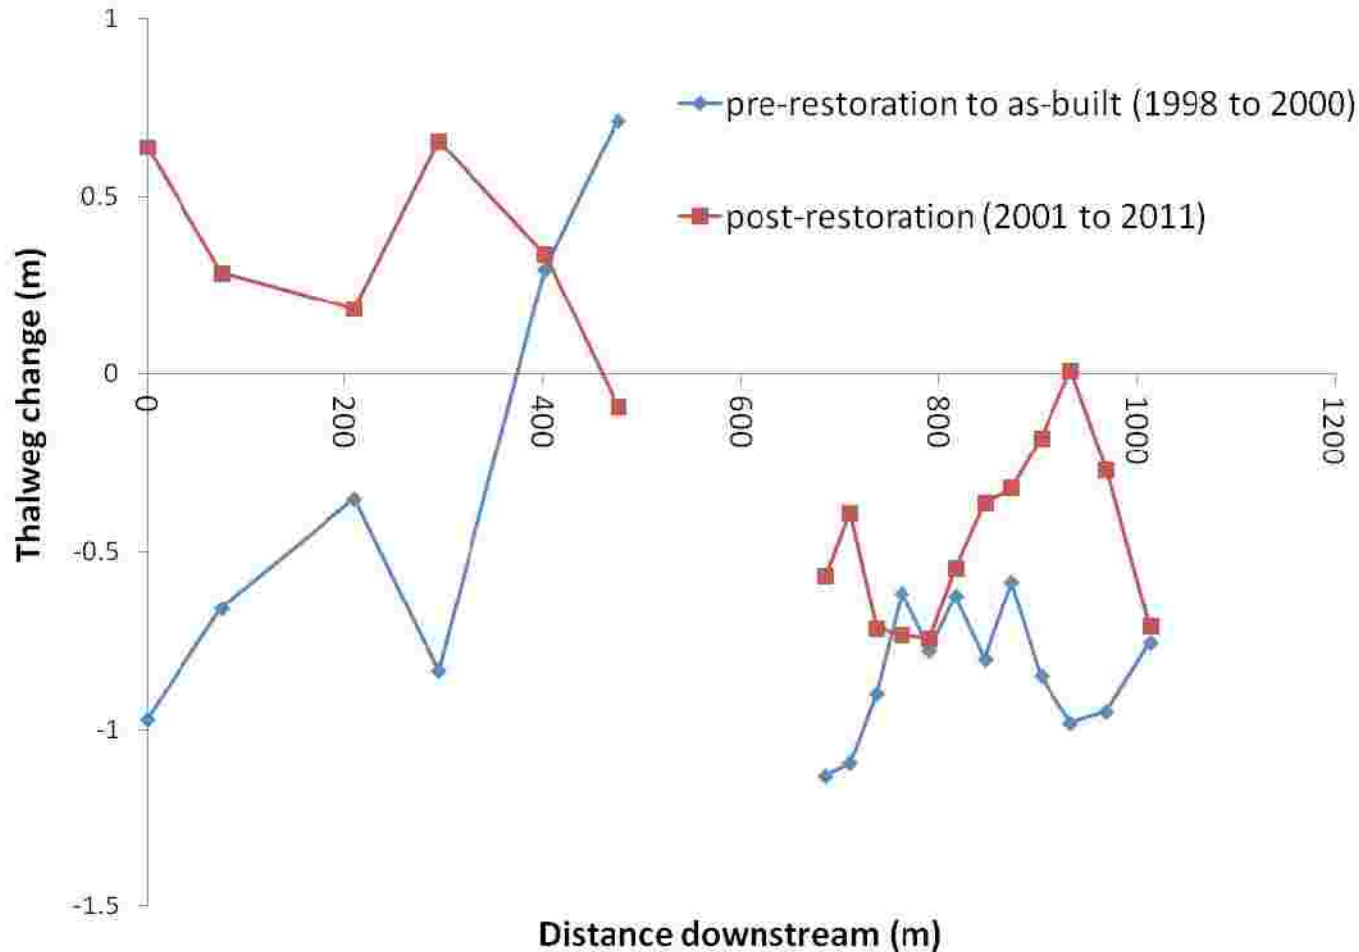
## Thalweg elevation change of the Wood River, 1998 - 2011

Cross sections taken every 3-4 years

Upstream and downstream data interrupted by boating access channel

Upstream and downstream responses are varied

Upstream:  
Excavation followed by aggradation

Downstream:  
Excavation followed by degradation

Intersection of Wood River and boat access channel is especially dynamic
